NACA RM A53F23

THE EFFECTS OF FENCES ON THE HIGH-SPEED LONGITUDINAL  
STABILITY OF A SWEEP-WING AIRPLANE

By Richard S. Bray

Ames Aeronautical Laboratory  
Moffett Field, Calif.

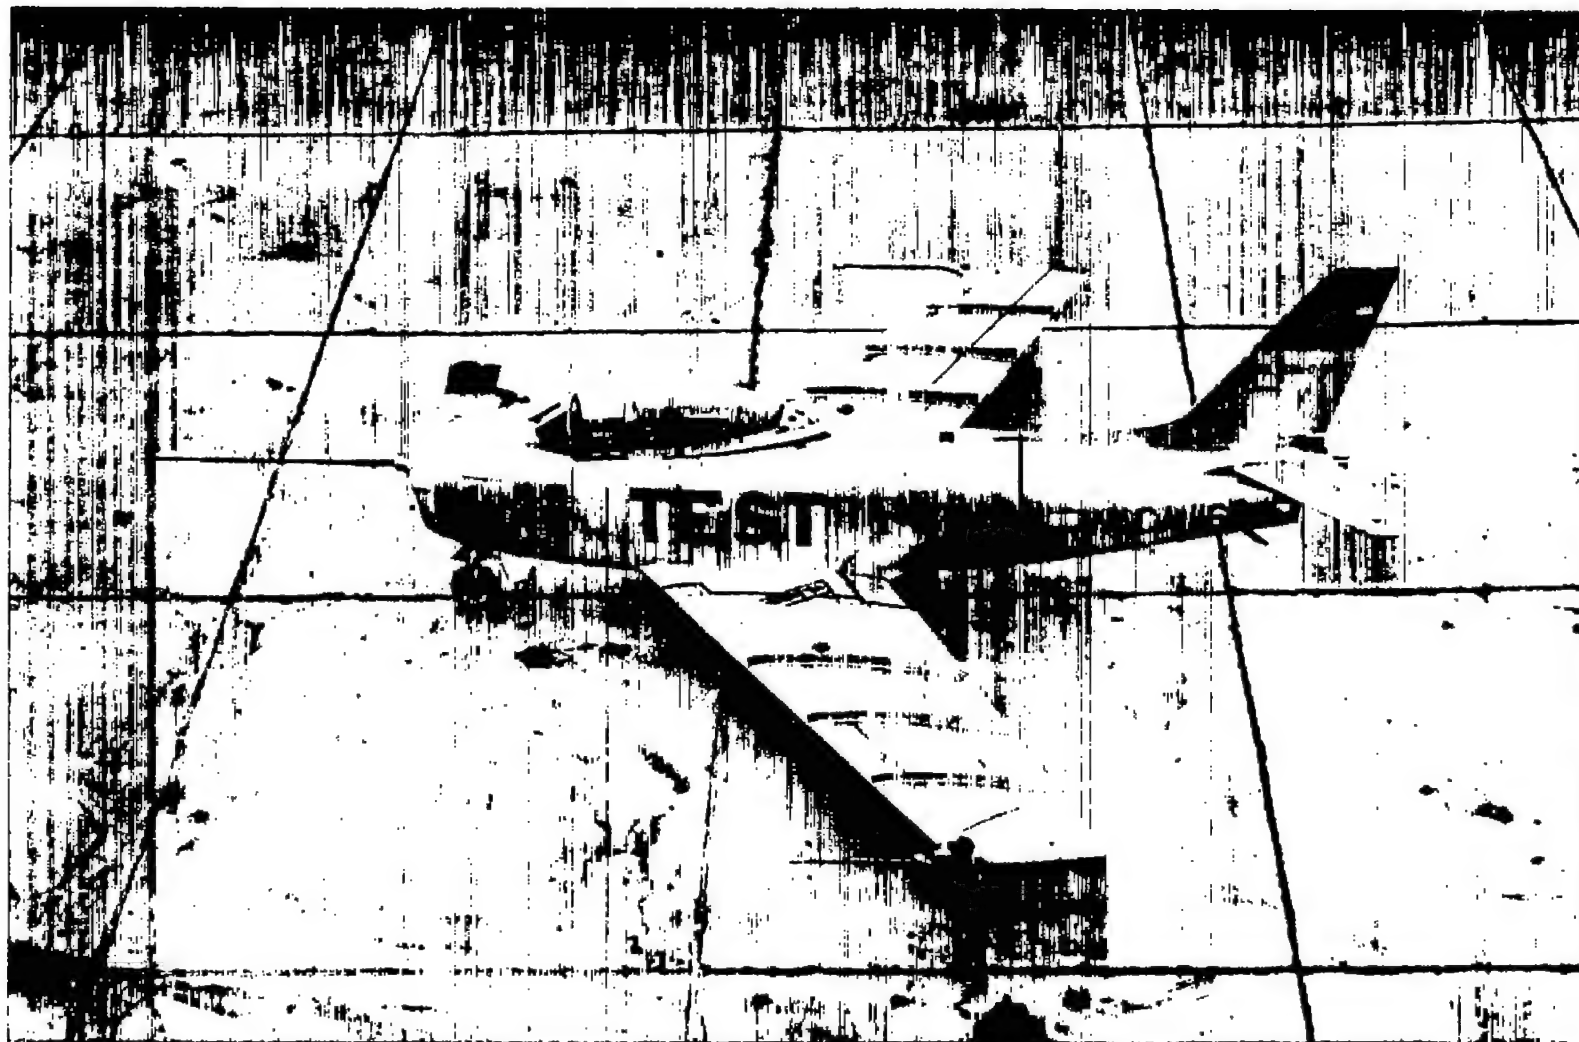
(a) General view.

Figure 3.- Fence configuration A.

The investigation included tests of the airplane unmodified and with nine individual fence configurations shown in table II. Five of these, configurations A through E, employed a multiple installation (three fences on each wing) and varied in chordwise extent. The fence locations were at 46, 63, and 80 percent of the wing semispan. Each of the fences of configuration A was tested individually to determine the effect of spanwise location. These configurations are designated A<sub>1</sub>, A<sub>2</sub>, and A<sub>3</sub>. One additional installation, configuration F, simulated that in use on the MIG-15 airplane. Photographs of a typical fence installation are shown in figure 3, and geometric details of the basic fence configurations are presented in figure 4.
